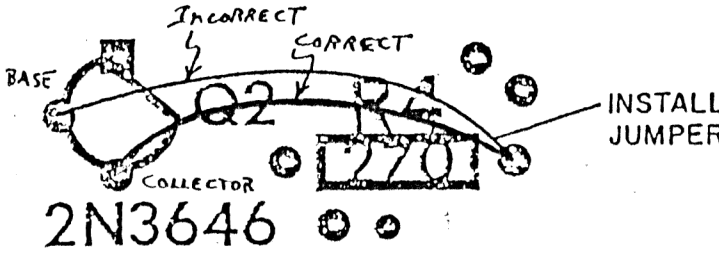
Mod#	ECO#	Date Issued	CHANGE	REASON
1	30	7/16/79	<p>Remove transistor Q2, Remove resistor R4 (optional), Install jumper between IC25-3 side of R4 → collector side of Q2.</p> <p>*Note that diagram in manual (Jul. '79) is incorrect:</p>

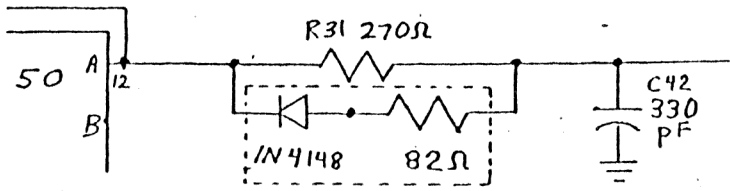
<p>Needed for compatibility with 64KZ Rev.J. Enables high-to-low propagation delay from IC50-12 to IC67-7 to equal the corresponding low-to-high propagation delay. Previously, AØ was too slow in going from a high-to-low transition.</p>

Mod#	ECO#	Date Issued	CHANGE	REASON
1	432	9-29-80	<p>Across R31, add an 82Ω resistor in series with a 1N4148 diode, with N side of diode facing IC50.</p> <p>schematic:</p>
