\* Legend J2 Rev.: no "IC17", BOARD MODIFICATIONS for 64KZ REV Solder side: J1  
 but "20 MHz" still present. Legend: J2 Date 6-1-81

ML 2

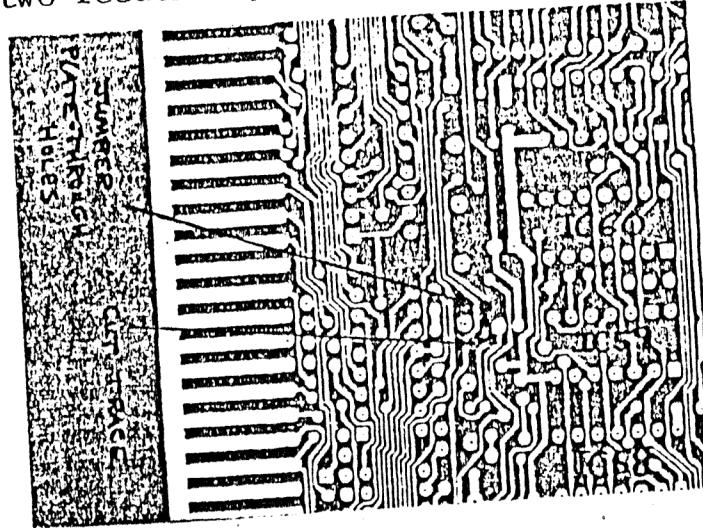
10 762 6-1-81

This will route sOUT through the de-glitching RC network (RN5 & C69) to IC59-10. Noise on sOUT taken directly off the bus could generate an invalid bank select pulse to IC8-9, causing the system to crash, when writing to memory addresses with lower address of 40H (also the bank select port).

On solder side, cut trace and jump the two feedthrough holes as shown.

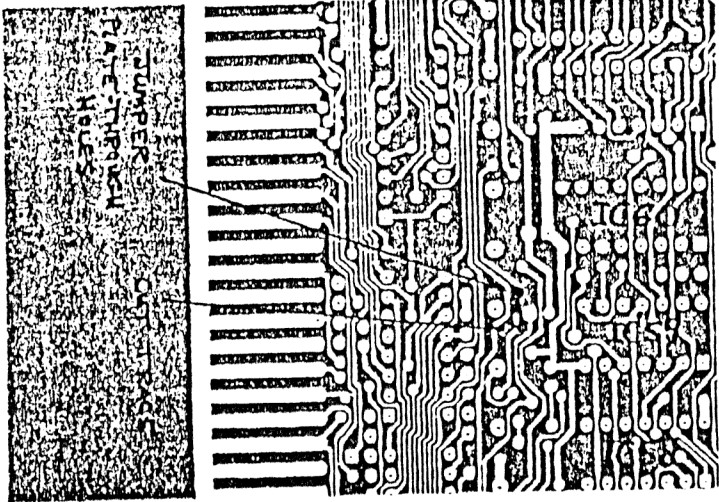
<p data-bbox="1400 383 2172 638">This will route sOUT through the de-glitching RC network (RN5 &amp; C69) to IC59-10. Noise on sOUT taken directly off the bus <u>could</u> generate an invalid bank select pulse to IC8-9, causing the system to crash, when writing to memory addresses with lower address of 40H (also the bank select port).</p>

Mod#	ECO#	Date Issued	CHANGE	REASON
1	615	2-18-81 4-24-81 <i>IN EFFECT</i>	Delete 20 MHz Crystal, 026-0002, from board.	Not needed. Delay line is now used.
2	762	6-1-81	<p data-bbox="638 383 1321 446">On solder side, <u>cut trace</u> and <u>jump</u> the two feedthrough holes as shown.</p>
